Manhole Inspection Summary

Manhole # S15GG2011MH

Location Address: **1808 DIXON RD**

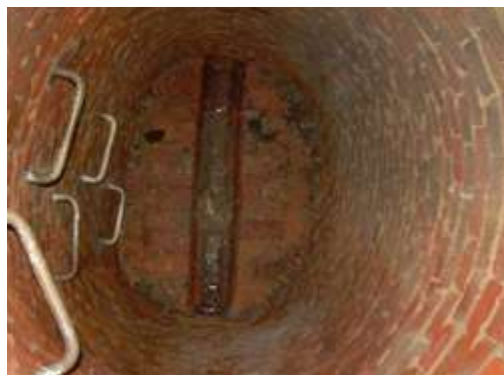
Top View

Corbel and Barrel infiltration. Evidence of surcharge - Bench debris. Channel debris.

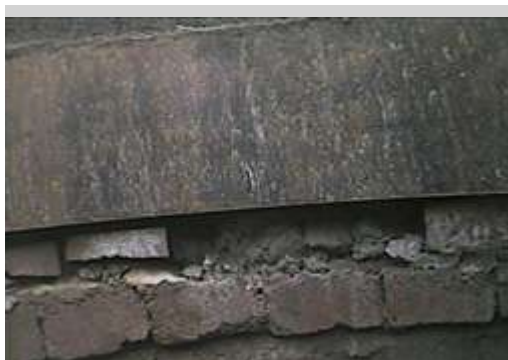
Defect

Adjustment deterioration, loose brick and infiltration.

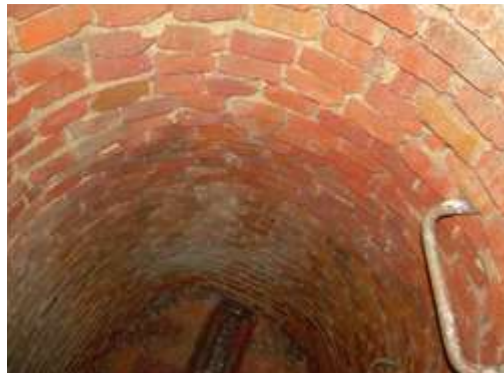
Defect

Adjustment and Barrel infiltration.

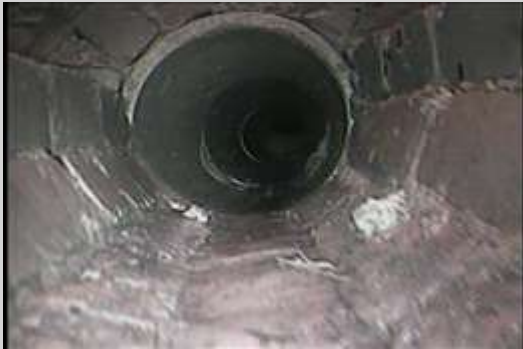
8 in. Circular Gravity Sewer Pipe Out @ 12 O'Clock

Infiltration: **None** Pipe Seal Cond: **Cracked**

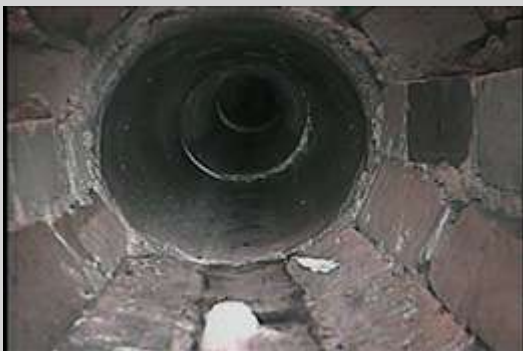
8 in. Circular Gravity Sewer Pipe In @ 6 O'Clock

Channel deterioration.

Infiltration: **None** Pipe Seal Cond: **Cracked**
